# Loss of Primary Containment (LOPC) KP 50,039 at Grissik Singapore Pipeline

Root Cause Analysis (RCA), Repair Method  
and Way forward

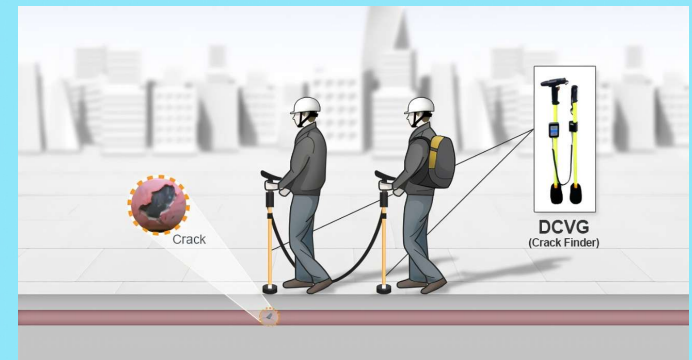
Illustration for DCVG to find coating damage

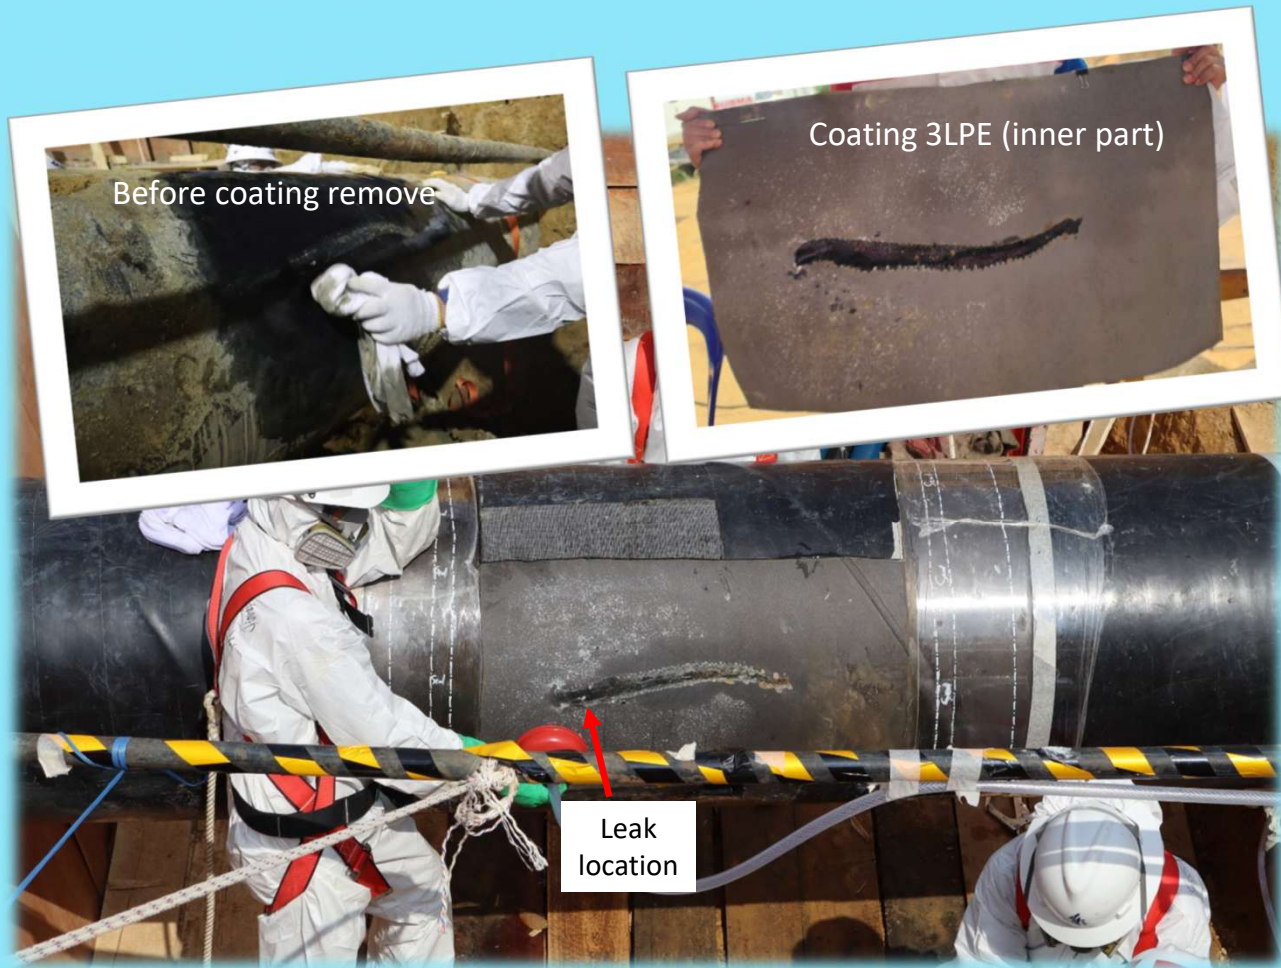
## Defect observation :

- Gouge (Mechanical damage)
- Defect length  $\pm 46$  cm and width  $\pm 4$  cm
- Pipeline coating was damaged along the gouge area
- Gas leak originated from gouge area
- Defect found was in axial orientation and the defect already penetrate to the pipe wall

At some point 3LPE damage and pipeline metal was exposed to environment causing localized corrosion. The corrosion propagate through pipe wall.

2. Perform permanent repair by Installing welded sleeve over clamp

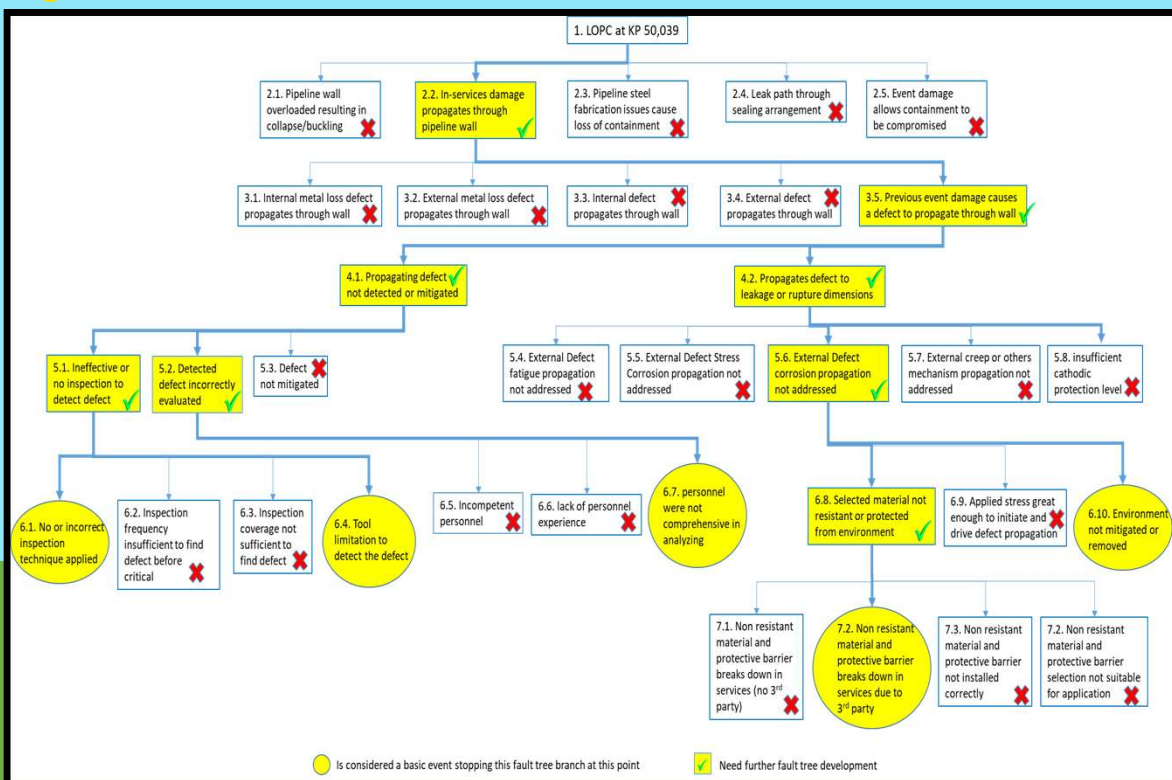
## Gouge - Mechanical damage

The intelligent pigging (SHR+MFL) was conducted year 2021, however the tool couldn't measure the defect, due to :

- Defect was below their tool specification therefore not categorize as defect.
- Defect orientation is in axial direction, the intelligent pigging which TGI run has capability to detect circumferential defect direction which based on TGI historical incident.
