# Loss of Primary Containment (LOPC) KP 50,039 at Grissik Singapore Pipeline

Root Cause Analysis (RCA), Repair Method  
and Way forward

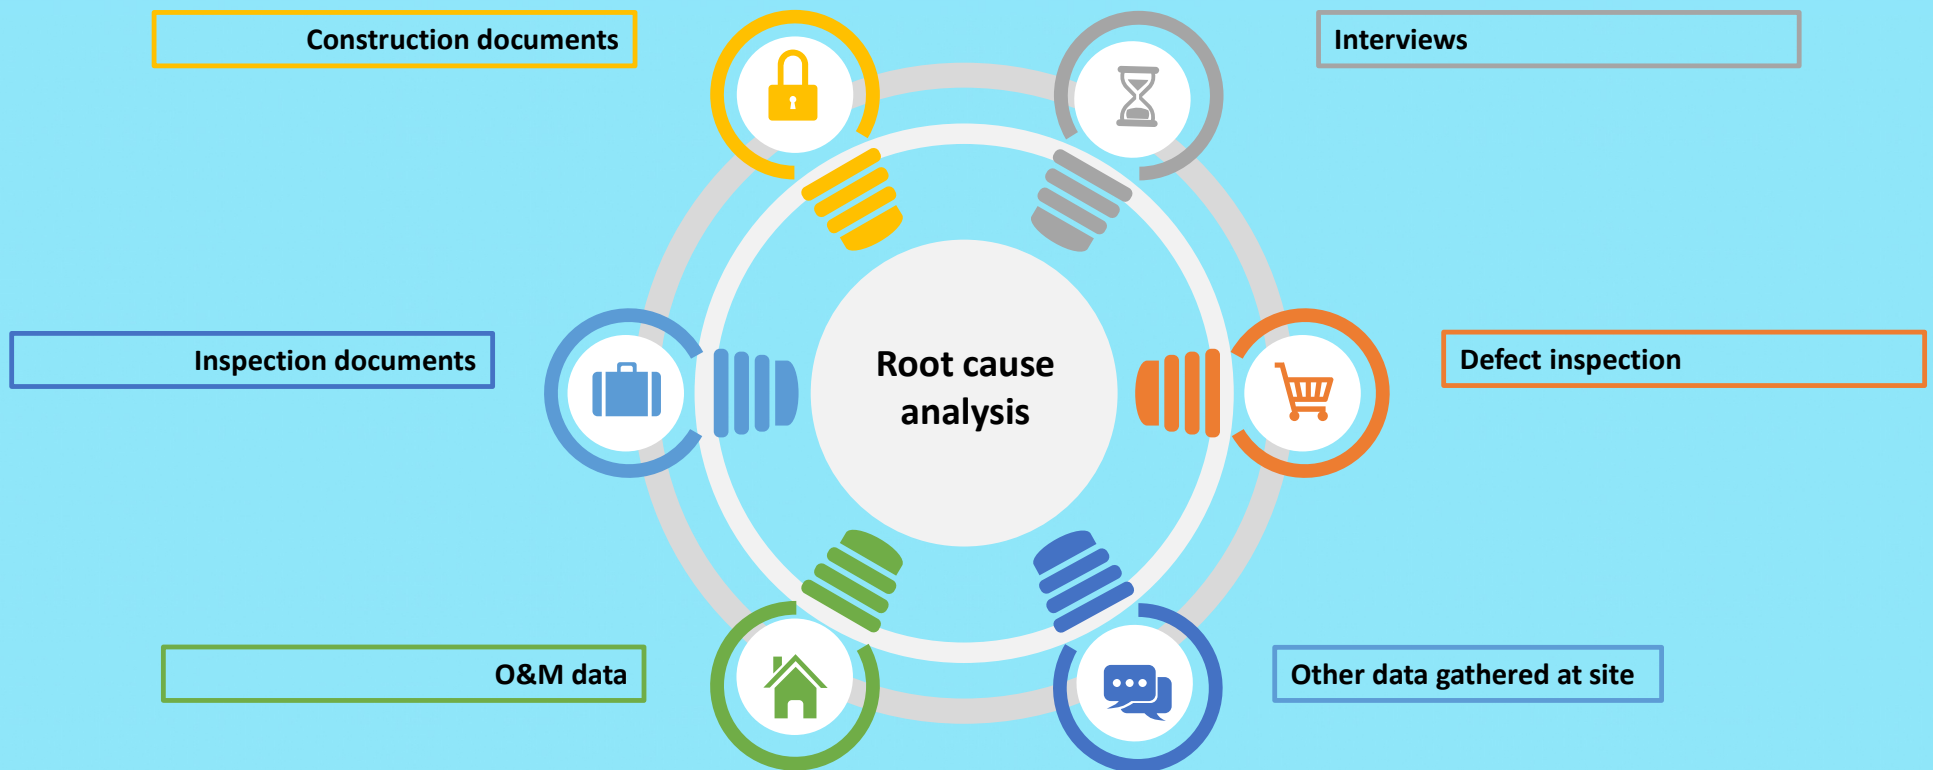
# Root Cause Analysis - Data Gathering

## Gouge - Mechanical damage

The intelligent pigging (SHR+MFL) was conducted year 2021, however the tool couldn't measure the defect, due to :

- Defect was below their tool specification therefore not categorize as defect.
- Defect orientation is in axial direction, the intelligent pigging which TGI run has capability to detect circumferential defect direction which based on TGI historical incident.

At some point 3LPE damage and pipeline metal was exposed to environment causing localized corrosion. The corrosion propagate through pipe wall.
